# Windows Insider Preview 17063 BSOD

**This issue is fixed**

**Note:** This issue is resolved in Macrium Reflect v7.1.2899 and later.

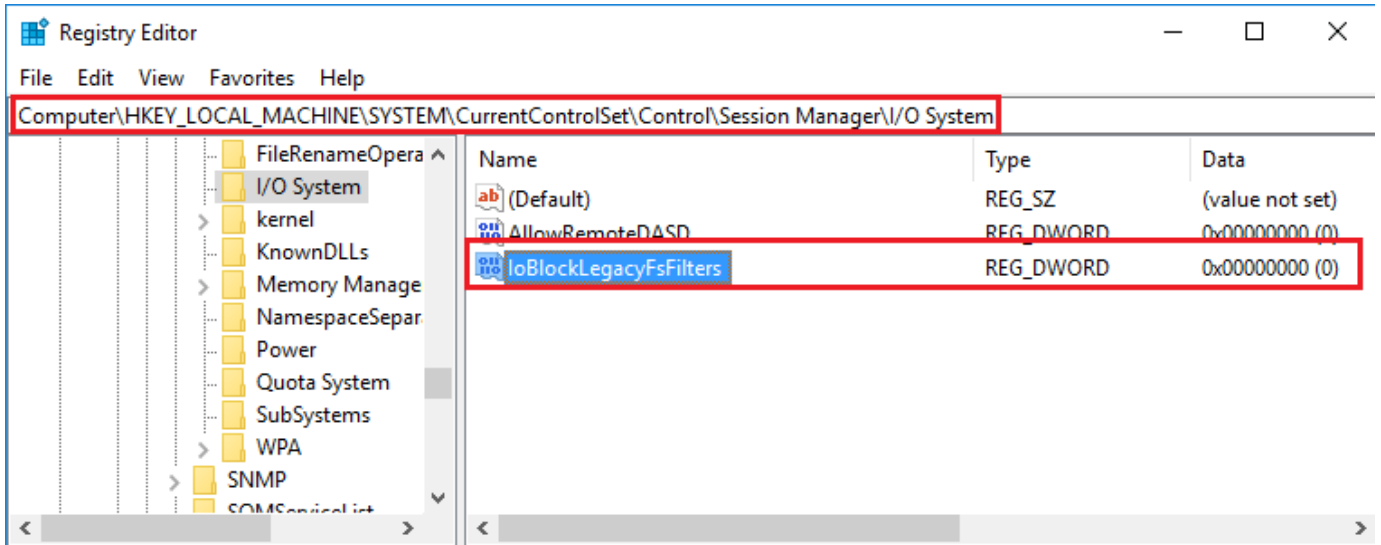
Since the [Windows 10 Insider Preview 17063](#) announced on the 20th December 2017 a new restriction has been added that unfortunately has caused the **Macrium Reflect Changed Block Tracker** (CBT) driver (MrCbt.sys) not to load at startup.

Windows 10 version 1607, introduced a new registry entry to block legacy drivers - **IoBlockLegacyFsFilters**, and this registry entry had to be explicitly set to exclude legacy drivers from loading. However, the default value for this new registry entry has been changed from '0' (Not blocked) to '1' (blocked) in the Insider Preview 17063 build of Windows 10. This means that no 'Legacy' kernel drivers, except for Microsoft's own legacy drivers, are loaded at boot time. Unfortunately this causes a fatal error when Windows starts if any legacy driver is designated as a boot start upper filter driver.

Assuming that this default registry change makes it to production versions of Windows then the solution is to re-write our CBT driver to prevent it being classified as legacy. In the short term creating **IoBlockLegacyFsFilters** with a value of '0' will allow MrCbt.sys to load and operate without problems.

<b>Key:</b>	HKEY_LOCAL_MACHINE\SYSTEM\CurrentControlSet\Control\Session Manager\I/O System
<b>Name:</b>	IoBlockLegacyFsFilters
<b>Type:</b>	REG_DWORD
<b>Value:</b>	0
